## PIC24FJ64GA004 Family Silicon Errata and Data Sheet Clarification

The PIC24FJ64GA004 family devices that you have received conform functionally to the current Device Data Sheet (DS39881D), except for the anomalies described in this document.

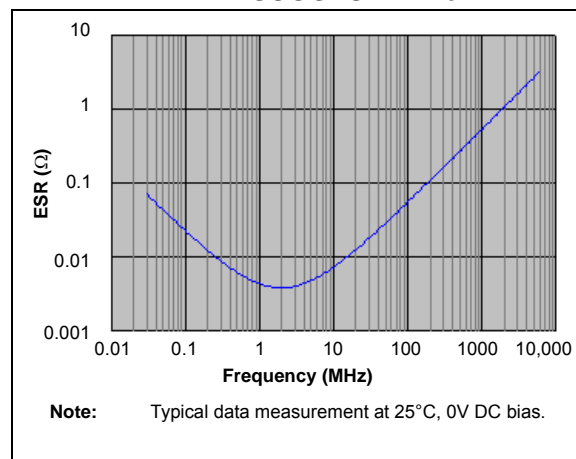
**FIGURE 2-3 FREQUENCY vs. ESR PERFORMANCE FOR SUGGESTED VCAP**

Designers may use [Figure 2-3](#) to evaluate ESR equivalence of candidate devices.

The placement of this capacitor should be close to VCAP/VDDCORE. It is recommended that the trace length not exceed 0.25 inch (6 mm). Refer to **Section 27.0 “Electrical Characteristics”** for additional information.

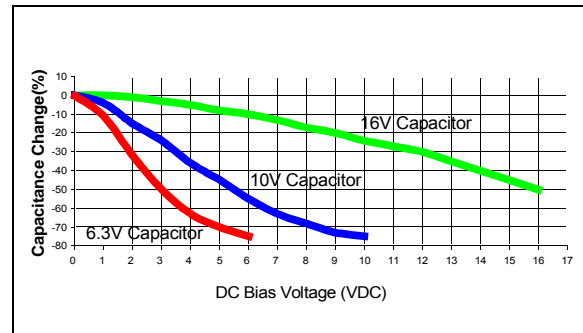
**FIGURE 2-4 DC BIAS VOLTAGE vs. CAPACITANCE CHARACTERISTICS**

A typical DC bias voltage vs. capacitance graph for 16V, 10V and 6.3V rated capacitors is shown in Figure 2-4.

When selecting a ceramic capacitor to be used with the internal voltage regulator, it is suggested to select a high-voltage rating, so that the operating voltage is a small percentage of the maximum rated capacitor voltage. For example, choose a ceramic capacitor rated at 16V for the 2.5V core voltage. Suggested capacitors are shown in Table 2-1.

The X5R and X7R capacitors typically exhibit satisfactory temperature stability (ex:  $\pm 15\%$  over a wide temperature range, but consult the manufacturer's data sheets for exact specifications). However, Y5V capacitors typically have extreme temperature tolerance specifications of  $+22\%/ -82\%$ . Due to the extreme temperature tolerance, a 10  $\mu\text{F}$  nominal rated Y5V type capacitor may not deliver enough total capacitance to meet minimum internal voltage regulator stability and transient response requirements. Therefore, Y5V capacitors are not recommended for use with the internal voltage regulator if the application must operate over a wide temperature range.
