PIC24FJ256GB110 Family Silicon Errata and Data Sheet Clarification

The PIC24FJ256GB110 family devices that you have received conform functionally to the current Device Data Sheet (DS39897C), except for the anomalies described in this document.

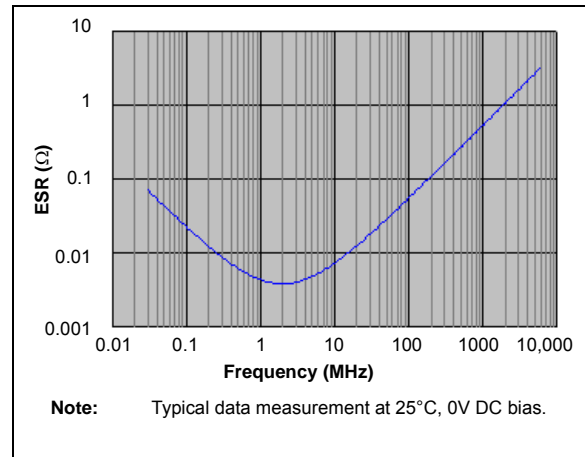
FIGURE 2-3 FREQUENCY vs. ESR PERFORMANCE FOR SUGGESTED VCAP

Designers may use **Figure 2-3** to evaluate ESR equivalence of candidate devices.

The placement of this capacitor should be close to VCAP/VDDCORE. It is recommended that the trace length not exceed 0.25 inch (6 mm). Refer to **Section 29.0 “Electrical Characteristics”** for additional information.

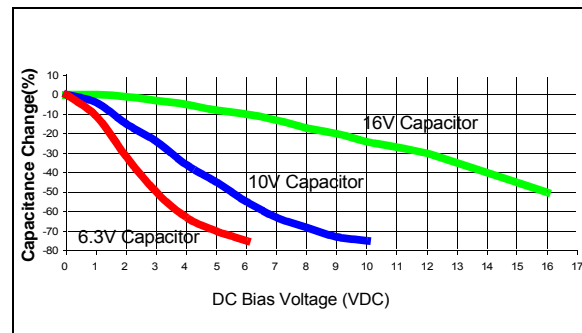
FIGURE 2-4 DC BIAS VOLTAGE vs. CAPACITANCE CHARACTERISTICS

A typical DC bias voltage vs. capacitance graph for 16V, 10V and 6.3V rated capacitors is shown in Figure 2-4.

When selecting a ceramic capacitor to be used with the internal voltage regulator, it is suggested to select a high-voltage rating, so that the operating voltage is a small percentage of the maximum rated capacitor voltage. For example, choose a ceramic capacitor rated at 16V for the 2.5V core voltage. Suggested capacitors are shown in Table 2-1.

The X5R and X7R capacitors typically exhibit satisfactory temperature stability (ex: $\pm 15\%$ over a wide temperature range, but consult the manufacturer's data sheets for exact specifications). However, Y5V capacitors typically have extreme temperature tolerance specifications of $+22\%/ -82\%$. Due to the extreme temperature tolerance, a 10 μF nominal rated Y5V type capacitor may not deliver enough total capacitance to meet minimum internal voltage regulator stability and transient response requirements. Therefore, Y5V capacitors are not recommended for use with the internal voltage regulator if the application must operate over a wide temperature range.
