# Intel® 80331 I/O Processor

## Specification Update

The Intel® 80331 I/O Processor may contain design defects or errors known as errata that may cause the product to deviate from published specifications. Current characterized errata are documented in this specification update.

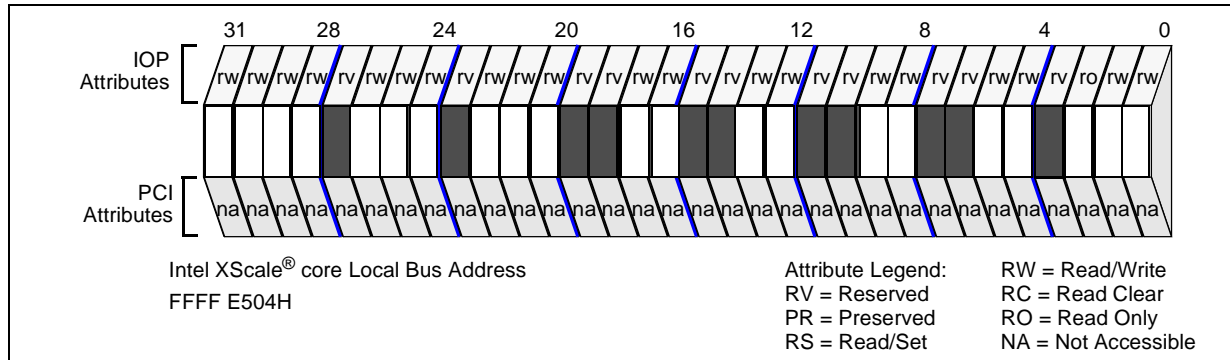
**Table 237. DDR SDRAM Control Register 1 - SDCR1**

Bit	Default	Description
31	0 <sub>2</sub>	<b>DQS# Disable:</b> Controls the behavior of the strobes as well as the configuration of the DIMM. 0 = DQS# Enabled for Differential operation, EMRS bit 10 will be programmed as zero. 1 = DQS# Disabled for Singled-ended operation, EMRS bit 10 will be programmed as one.
