ERRATA SHEET

Date: November 01, 2001
Document Release: Version 1.0
Devices Affected: P89C660, P89C662, P89C664, P89C668
(referenced to as P89C66x in this document)

On-chip Flash 8-bit microcontroller
Errata Sheet

P89C66x

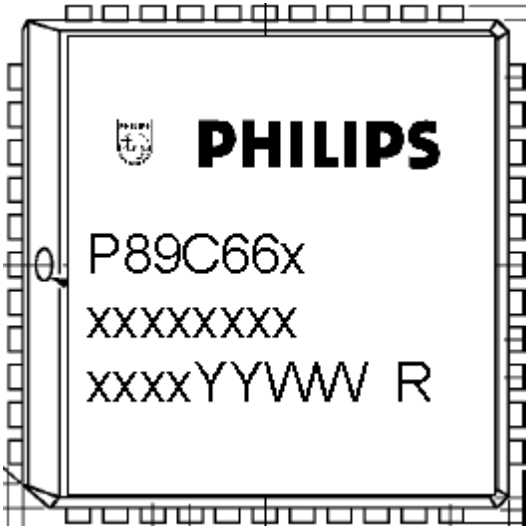
The P89C66x devices have the following top-side marking (PLCC44 package shown):

The last letter in the third line (field 'R') will identify the device revision. This Errata Sheet covers the following revisions of the P89C66x:

Field 'YY' states the year the device was manufactured. Field 'WW' states the week the device was manufactured during that same year.
