PIC18F87J11 Family Silicon Errata and Data Sheet Clarification

The PIC18F87J11 family devices that you have received conform functionally to the current Device Data Sheet (DS39778D), except for the anomalies described in this document.

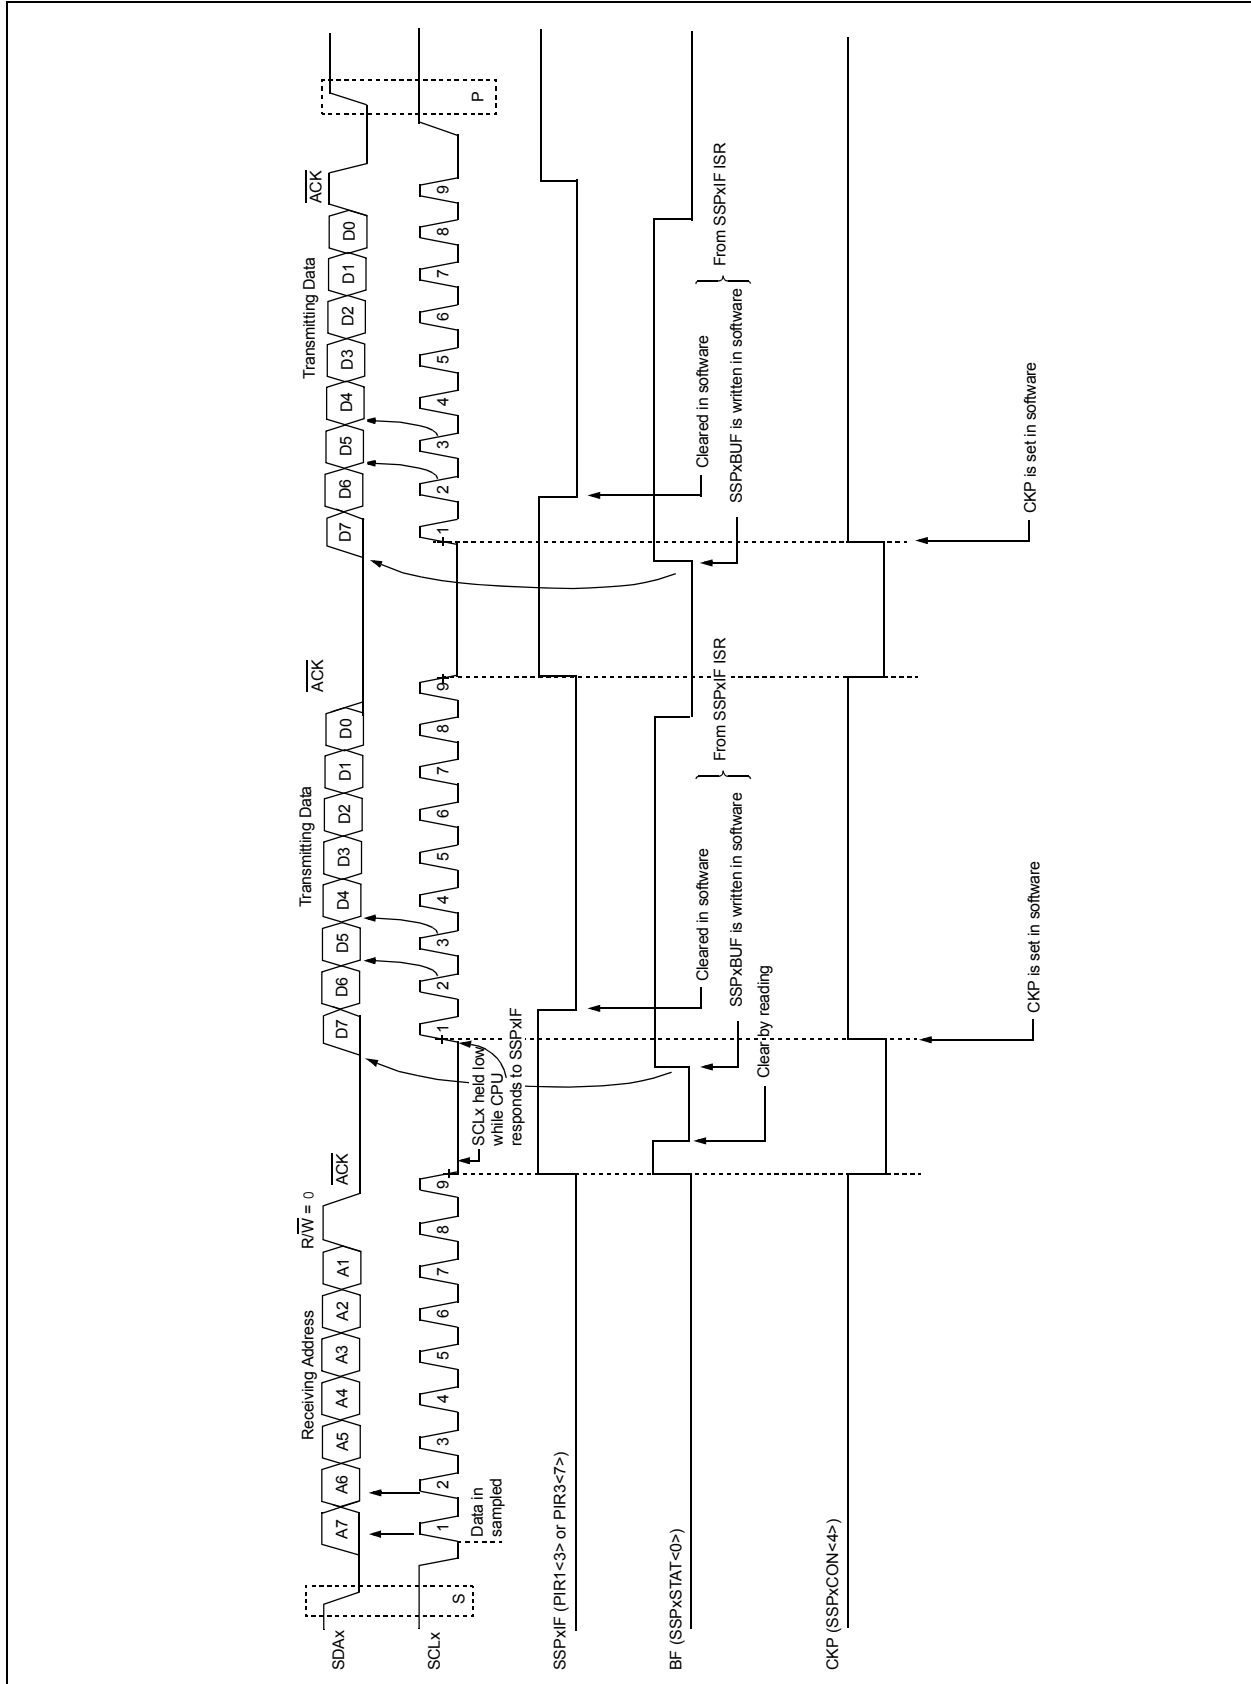
FIGURE 19-10: I²C™ SLAVE MODE TIMING (TRANSMISSION, 7-BIT ADDRESS)

7. Module: Figure 19-10: I²C™ Slave Mode Timing (Transmission, 7-Bit Address)

On page 244, the figure is replaced with the new timing diagram provided in [Figure 19-10](#).

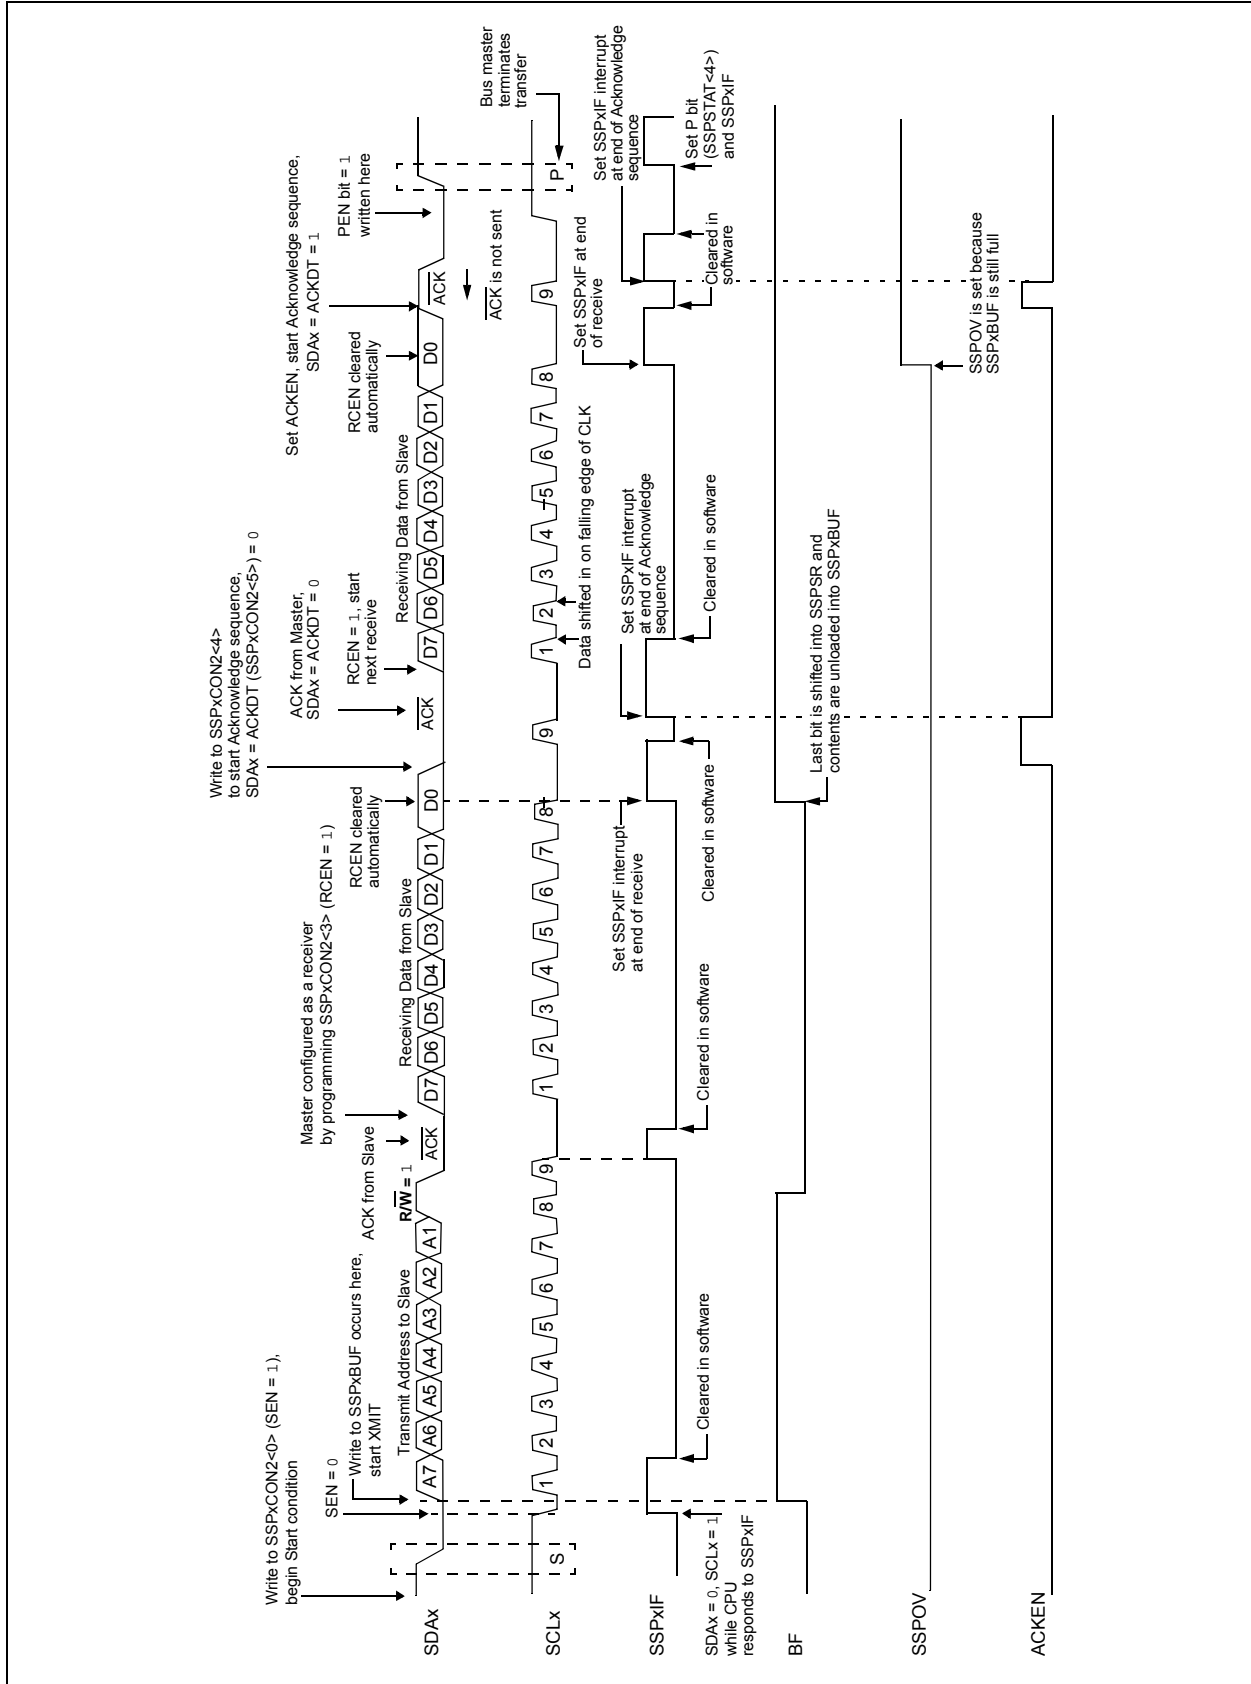
FIGURE 19-24: I²C™ MASTER MODE WAVEFORM (RECEPTION, 7-BIT ADDRESS)

8. Module: **Figure 19-24: I²C™ Master Mode Waveform (Reception, 7-Bit Address)**

On page 261, the condition (R/\overline{W}) when the Acknowledge signal (ACK) is received from the slave, after transmitting the address to the slave, is changed to '1'. The changed value is indicated in bold text in [Figure 19-24](#).

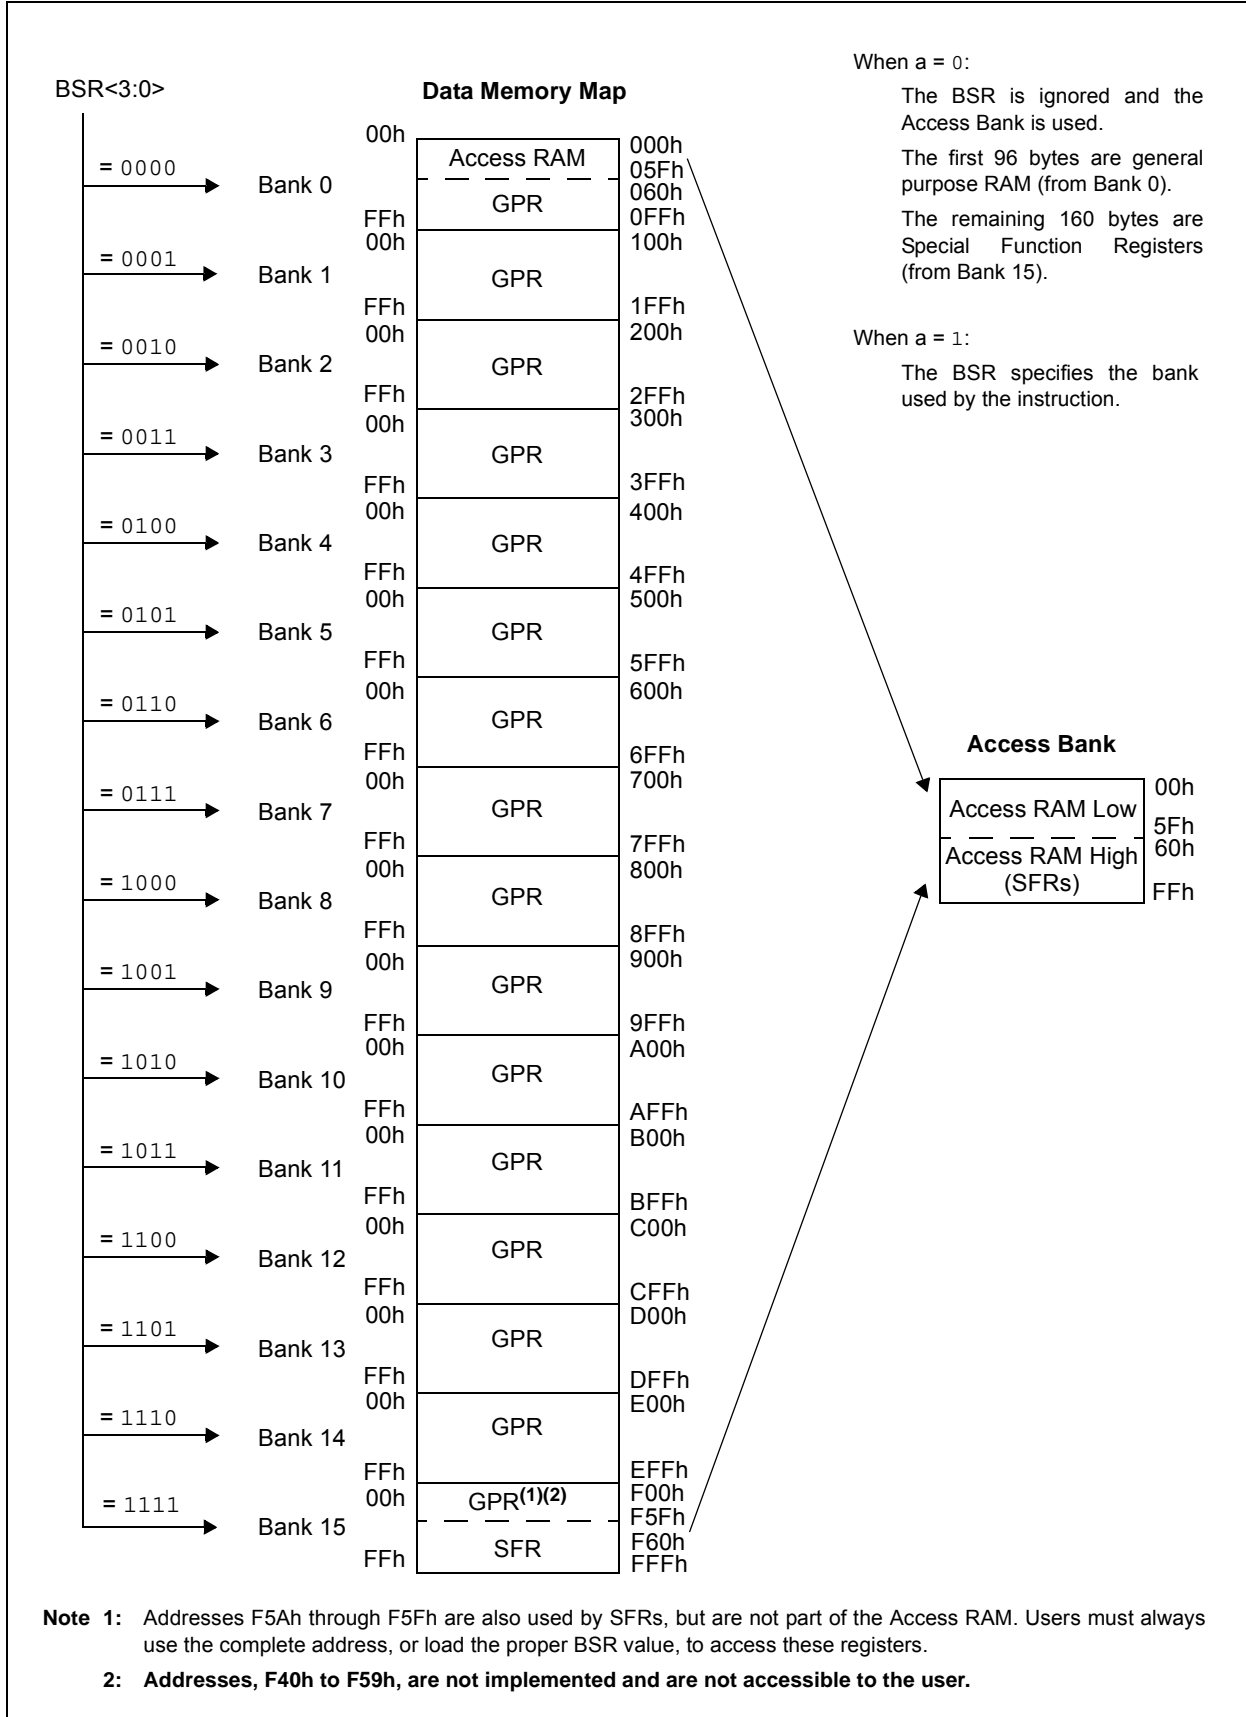
FIGURE 5-7: DATA MEMORY MAP FOR PIC18F87J11 FAMILY DEVICES

11. Module: Memory Organization

On page 73, in Figure 5-7, Note 2 has been added. The additional note is indicated in bold text in Figure 5-7.

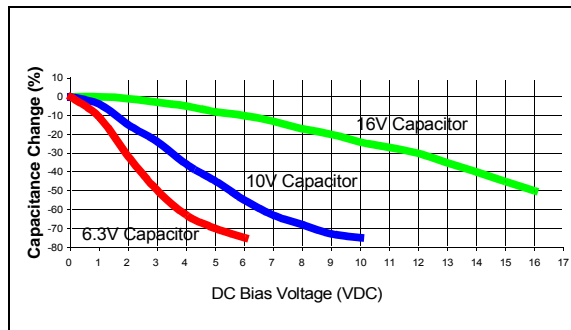
FIGURE 2-4 DC BIAS VOLTAGE vs. CAPACITANCE CHARACTERISTICS

In addition to temperature tolerance, the effective capacitance of large value ceramic capacitors can vary substantially, based on the amount of DC voltage applied to the capacitor. This effect can be very significant, but is often overlooked or is not always documented.

A typical DC bias voltage vs. capacitance graph for X7R type and Y5V type capacitors is shown in [Figure 2-4](#).

When selecting a ceramic capacitor to be used with the VDDCORE voltage regulator, it is suggested to select a high-voltage rating, so that the operating voltage is a small percentage of the maximum rated capacitor voltage. For example, choose a ceramic capacitor rated at 16V for the 2.5V VDDCORE voltage. Suggested capacitors are shown in [Table 2-1](#).
